## Lead-Contamination in Lead-Free Electronics Assembly

Karl Seelig and David Suraski

AIM

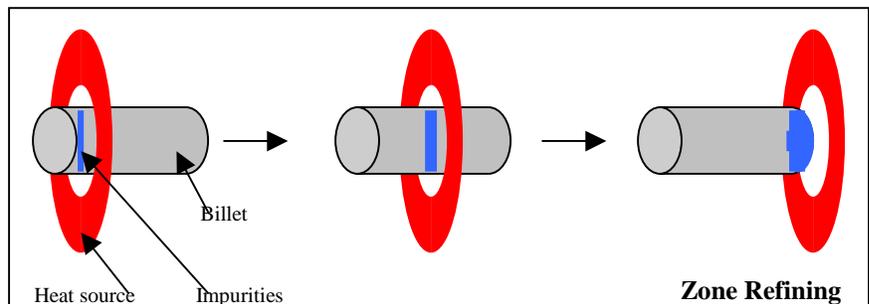
Fig. 1

It is important to note that lead that contaminates a lead-free solder joint is not distributed uniformly through the joint; rather, the Pb localizes in the last point to cool. This is similar in dynamics to “zone refining”, a process utilized to refine high-purity elements. In zone refining, a heat source traverses across a billet. As this occurs, the elemental impurities are collected in the liquid phase and are condensed at the last point to cool (the end of the billet), which can then be removed (Fig. 1).

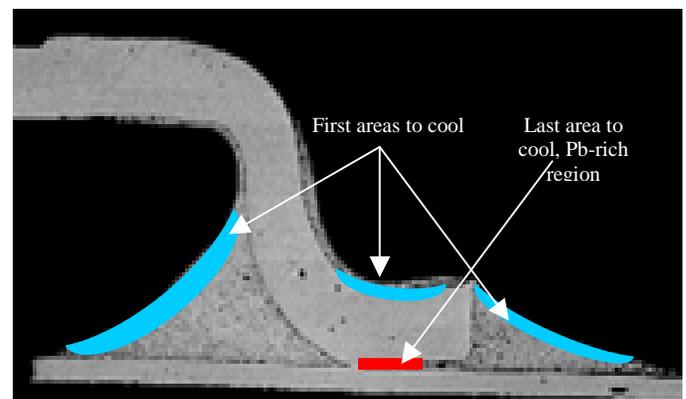
Fig. 2

Just as in zone refining, lead as an impurity in a solder joint migrates to the last area of the joint to cool. This occurs under the middle of the component lead at the solder joint-PCB interface (Fig. 2), which is inevitably the area of a solder joint that results in a failure. When this occurs, the joint forms pockets and the

grain structure is disturbed. These Pb-rich regions are lower in melting temperature and may cause dewetting during soldering.

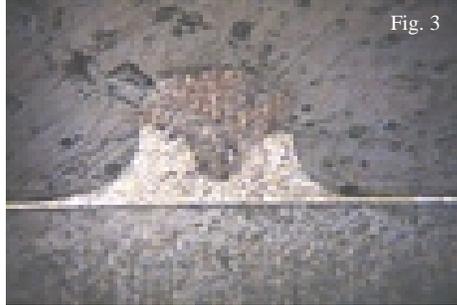
Fig. 3 illustrates how much of a lead sphere dissolves into a Sn/Ag system during a normal reflow cycle. Fig. 4 is a close-up of Pb pockets that are dispersed through a through a Sn/Ag system. This dispersion is a common part of wetting: as the solder wets, the Pb dissolves into the joint. As the Pb starts concentrating in pockets, this starts forming a eutectic of Sn/Pb/Ag with a melting point of 179°C vs. 221°C

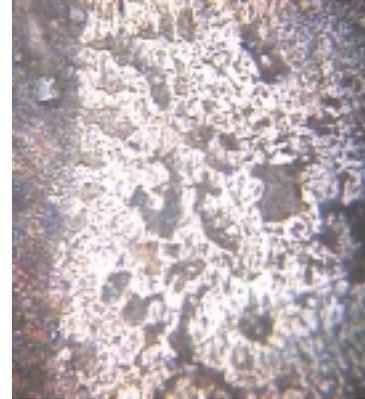
Fig. 4

for Sn/Ag or 217-218°C for Sn/Ag/Cu. This phase occurs during cooling, and the slower the cooling, the larger the pocket of this lower melting temperature alloy will form. In essence, this pocket of alloy acts as a void in the solder joint. As the component heats and cools during its product life, this void will eventually lead to joint failure. Failure rates related to this issue typically occur relatively quickly (in less than 400 thermal cycles).

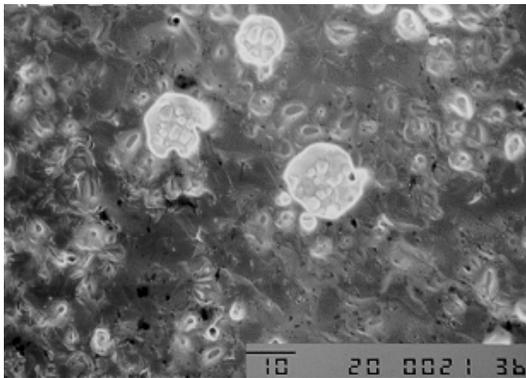
A leading multinational electronics manufacturing company recently experienced field failures in a product assembled with a tin/silver/copper alloy, and tin/lead coated components and leads. Samples of the failed solder joints were viewed using SEM to determine the possibility of lead or other contamination that could have lead to the failure. EDS was used to determine if there was contamination in the solder joint. As shown in Fig.7, the EDS revealed lead contamination levels ranging from 3% to 10%. In Fig. 8 the mating area of the lead-free alloy and tin-lead parts is shown. The Sn/Ag/Cu alloy is seen in the lighter areas and the darker Sn/Pb areas surround it.

This intergranular phase exhibits poor adhesion to the lead-free alloy, thus causing the grain separation.

This particular grain boundary interface that led to the failure could be the result of a specific heat cycle being utilized. In other words, utilizing different heating profiles during assembly may minimize, but not eliminate, this problem. To determine this, more joints, processed using different thermal profiles, would need to be investigated.

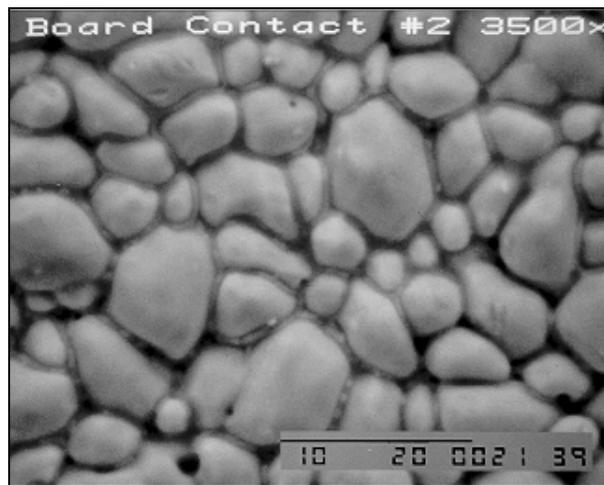
Fig. 9

The failure is an intergranular separation and is being driven by lead in the solder. Figure 9 is a 3500X photo that shows a distinct phase between the normal grains that causes the grains to separate easily. The lead forms a ternary alloy of tin/lead/silver that is trying to go to the eutectic at 179°C. This alloy is surrounding the grains of the lead-free alloy.
